Materials and Techniques of *Art Nouveau* Architecture in Italy and Portugal: a First Insight for a European Route to Consistent Restoration

A. C. Dell'Acqua¹, E. Franzoni², F. Sandrolini² and H. Varum³

The results of the investigations on building materials and techniques of Casa Major Pessoa, a typical *Art Nouveau* construction in Aveiro (Portugal), and two coeval *Art Nouveau* buildings in Bologna (Italy) are presented as a methodological contribution to the restoration of this kind of buildings. This is the first step to ascertain the existence of a common thread between local materials, technologies and architecture in European countries at the same period. A holistic approach was adopted: materials were investigated along with architectural, structural and technological features, in order to achieve a first insight into the *Art Nouveau* architecture in Europe in particular for its consistent restoration without loss of historical memory.

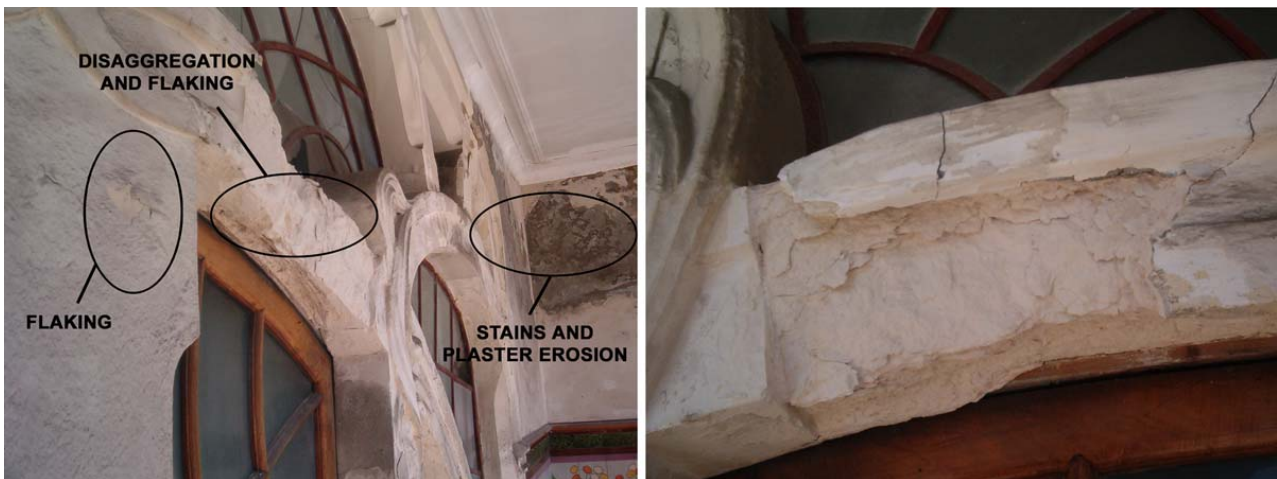
The critical aspects influencing the durability of the building and its global stability were identified: 1) degradation of the façade limestones (Fig. 2-3), mainly due to environment exposure; 2) excessive deformation of the façade due, on the one hand, to changes in the soil foundation conditions in the vicinity of the building and, on the other hand, to the detachment between the façades and the load-bearing walls; 3) infiltrations in the wood roof and floor systems due to bad performance and lack of maintenance of the roof coverings and drainage systems; 4) moisture

Figure 2: Casa Major Pessoa: materials decay in the south front open lodge at the ground floor (left) and a detail of the limestone decorations deep decay (right)

The *arte nova* decorations in the south façade (Fig. 1-2) are made of typical Portuguese limestone ($\text{CaCO}_3 \approx 99$ wt%) with high open porosity (30 vol %). The remarkable amount of chlorides (at least 0.23 wt %) comes from the local marine spray and causes the overall material’s decay so evident in Fig. 2 and 3.

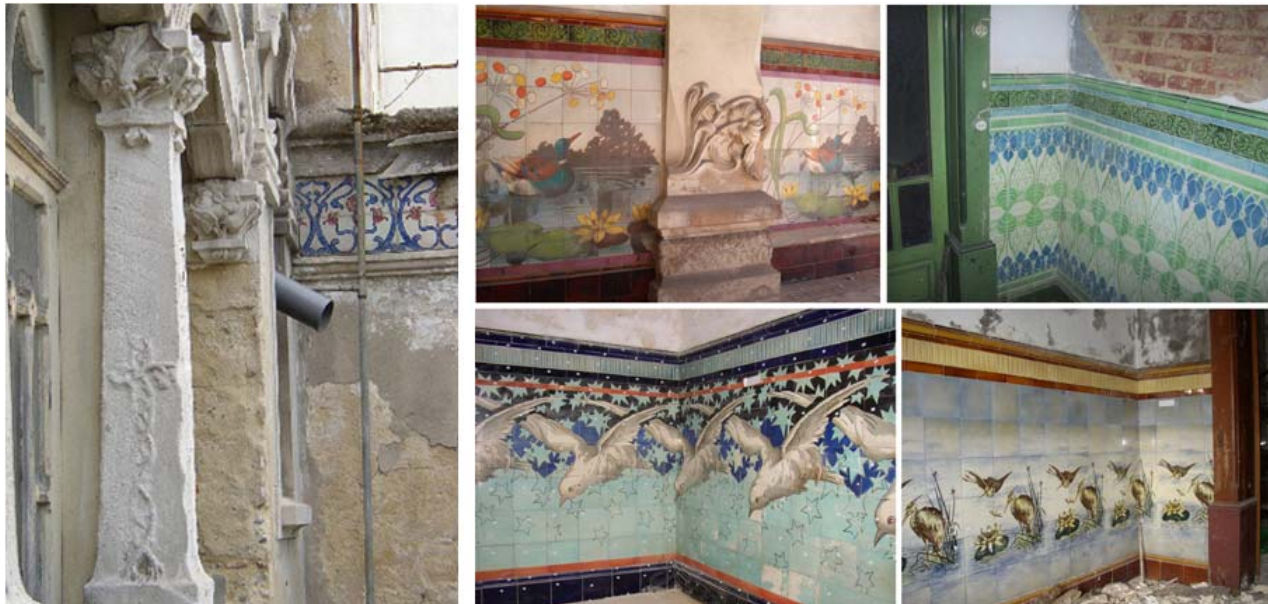
Immediately after the building's purchase by the Aveiro Municipality, the rehabilitation process was initiated, in order to safeguard the building's rich façade decorations, as well as the *azulejos* (traditional hand-painted ceramic tiles [15], not decayed) at its interior, in the typical Portuguese *arte nova* style (Fig. 3).

Figure 3: Casa Major Pessoa: materials' decay in north front (left) and azulejos (right)

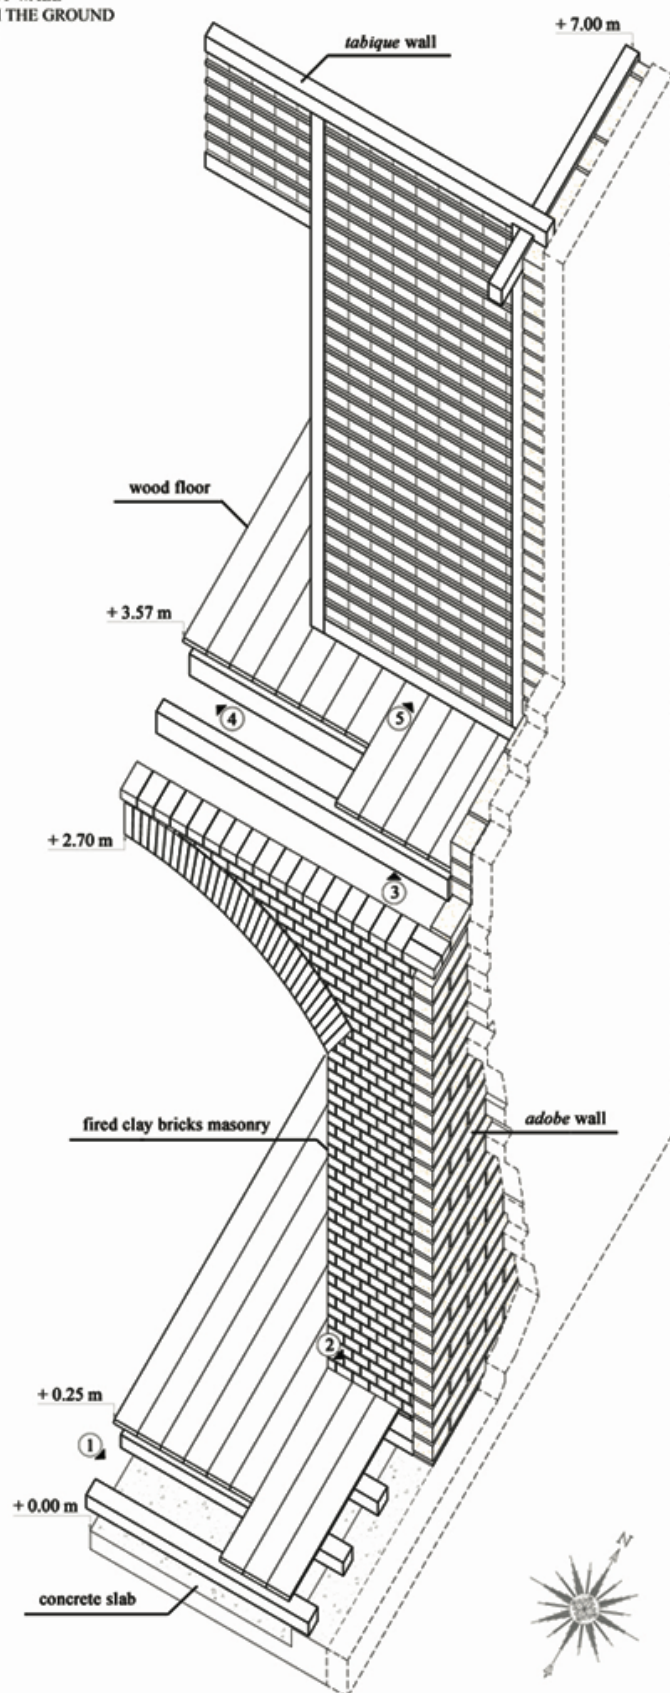
Figure 4: Casa Major Pessoa: sketch of the east wall's connection to the ground and first floors

In fact, during the inspections to the building, it was observed that the façades were completely detached from the adobe structural walls, due to differential creep, on the one hand, and to the foundations settlement, on the other hand. The poor soil foundation conditions in this point of the city of Aveiro must be remarked.

Thus, considering all these aspects and constraints, for the structural rehabilitation design of the building the following measures were recommended: on the one hand, to create a secondary system to connect the existing vertical components (adobe load-bearing walls and façades) and, on the other hand, to improve the global safety of the building to lateral loads, as those induced by vibrations, earthquakes and wind. A steel structural frame system, founded on piles, was adopted, which was completely embedded in the existing adobe walls, not to change the original architecture of the building.

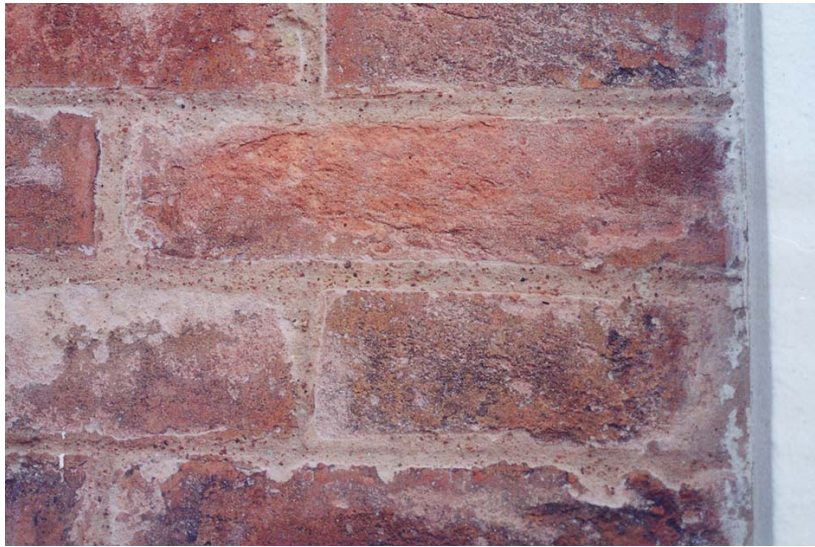
Figure 8: Palazzina Liberty: the external brick joints containing potsherd, resembling traditional “*sagramatura*”

- The outdoor filling of the mortar joints of the fired clay bricks of the walls is made of lime and *potsherds*, added with silica sand as fine aggregate (Fig. 8), while the embedding mortar beneath is a common lime mortar with a silica-limestone sand. This external, brick-coloured filling gives the wall higher durability to outdoor environment and resembles the ancient “*sagramatura*”. The *sagramatura* [35] was a very ancient surface finishing technique (typical of Bologna and of many other Italian cities), in which the newly built wall was continuously rubbed by a fragment of the same fired clay brick: in this way, the lime mortar gave rise to a fine mixture with the scraped brick powder and hence a very thin protective layer formed on the wall surface by harden-

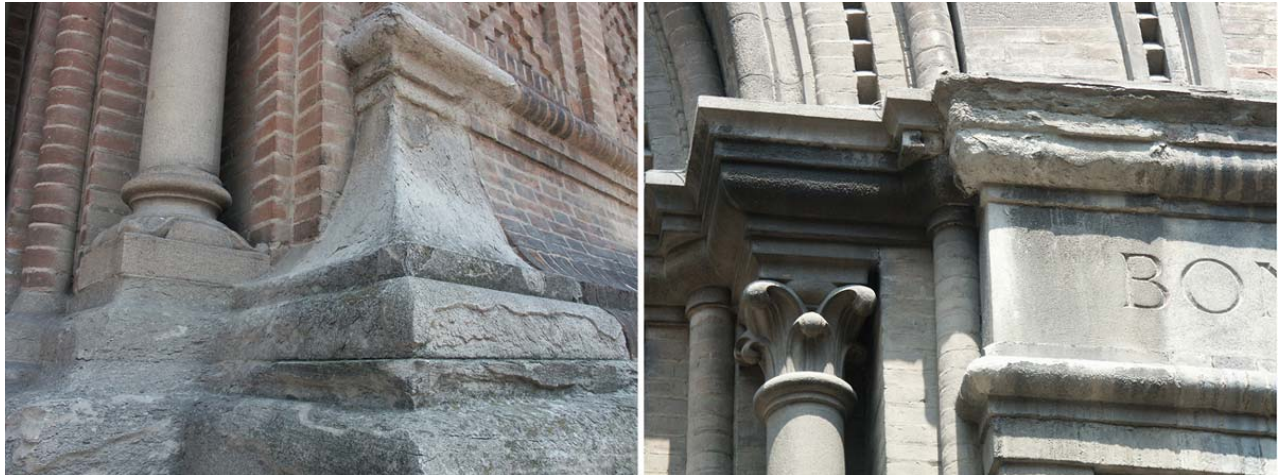
Figure 9: The Sacro Cuore church: natural stone basis and a precast concrete column in the main façade (left). Ledge partially made of stone and concrete in the side façade (right)

- On the contrary, the local sandstone used in the building, characterised by a high carbonates content (about 65 wt %) and significant fractions of silica and feldspars, is deeply decayed (Fig. 9). Due to atmospheric pollutants, leading to acid and sulphatic attack [37], the deteriorated zones show a lower amount of carbonates (about 47 %) and a meaningful content of sulphates (about 0.5 wt %) in the sheltered zones. Where the decayed stone ledges were repaired with cement mortars during last decades, pop-out is presently appearing.
- Likewise to the Palazzina Liberty, a weaker and less durable material, the sandstone, has been used as base of the concrete precast elements, e.g. the columns in the façades (Fig. 9-10).

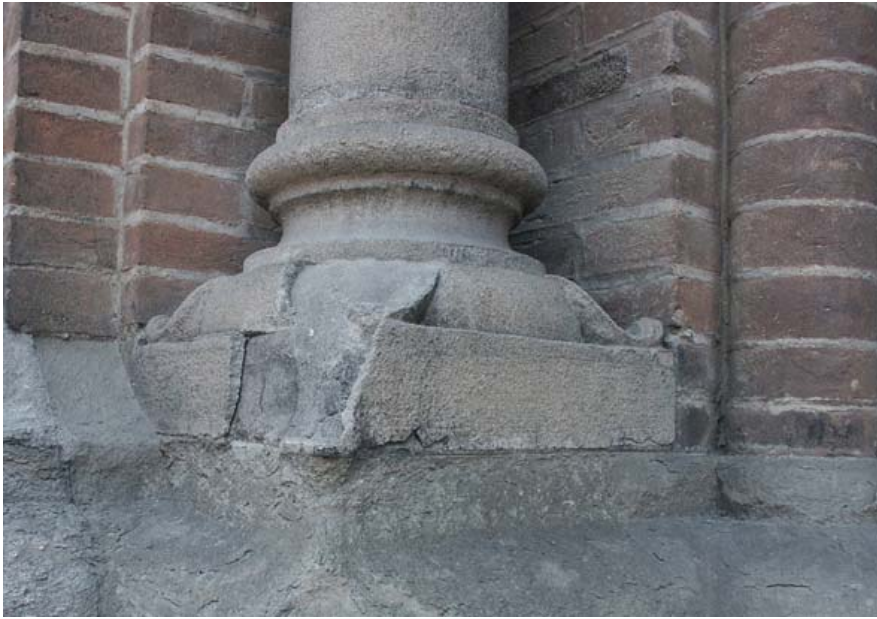
ronment during years. This external layer can be observed in Fig. 10, where an accidental detachment occurred.

Figure 10: The Sacro Cuore church: an occasional detachment of the external mortar layer in a concrete column and its sandstone basis
